**PRE-DEMOLITION/DISPOSAL ASBESTOS SURVEY REPORT
AT THE
FORMER BAYONNE BARREL & DRUM PROPERTY
150-154 Raymond Boulevard
Newark (Essex County), New Jersey**

**CODE Enviro-Sciences, LLC.
400 Middlesex Avenue
Carteret, New Jersey 07008
Project No. 251248**

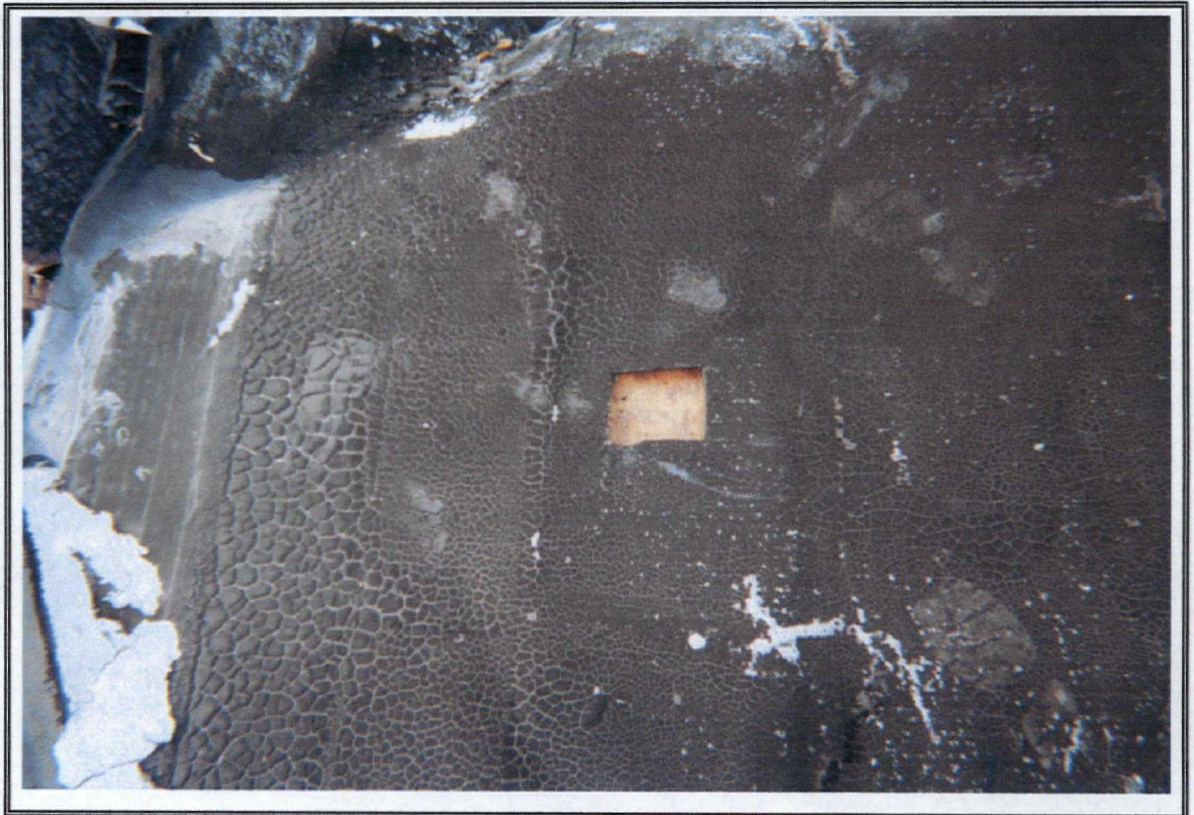
Photo No. 1

Only sample 001-Bldg6 (roofing material) was collected and analyzed from Building 6. The results did not indicate any detectable asbestos.

Building 6 Roofing Materials (sample #001-Bldg6).

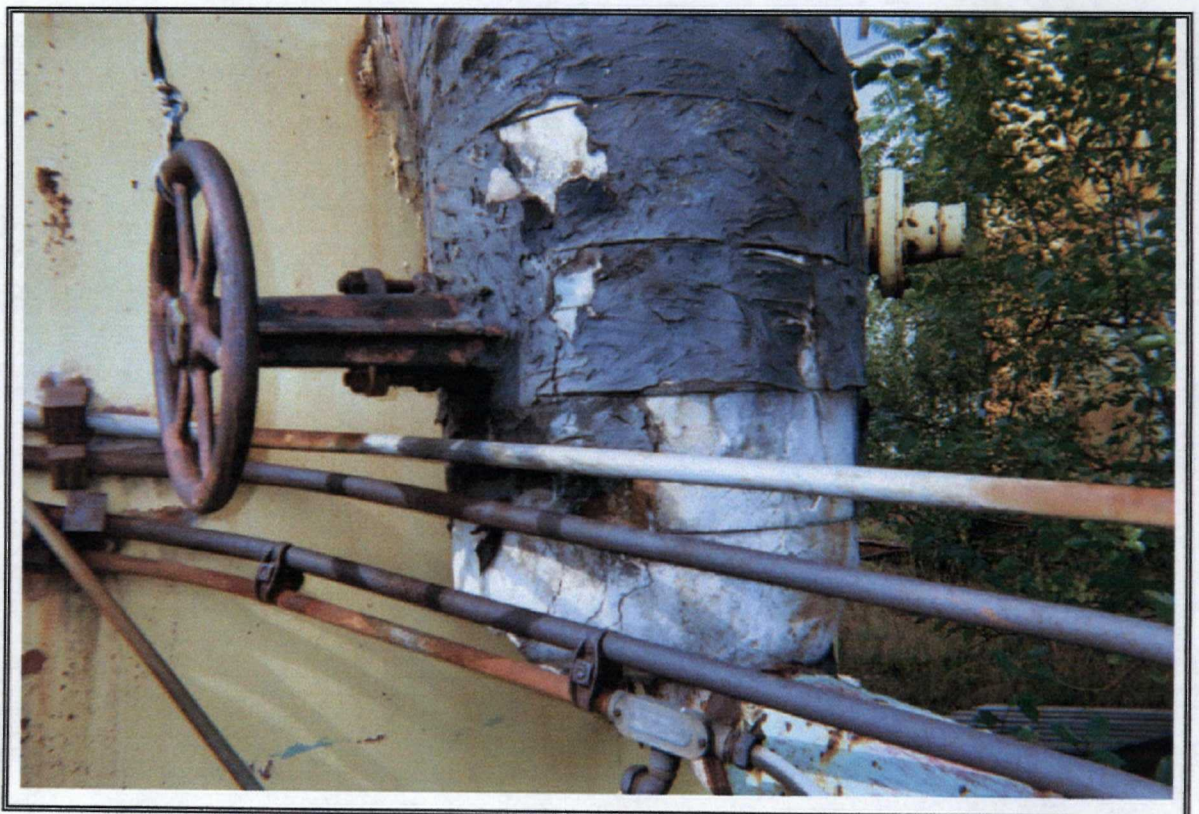
Photo No. 2

Only one sample was collected and analyzed from the pipe elbow of the 60,000-gallon above-ground storage tank. Samples 002-AST and 003-AST were collected from the outer wrap and inner insulation of the pipe elbow. The results of these samples exhibited the presence of chrysotile asbestos at 10% and 15%, respectively.

60,000 AST piping wrap and insulation samples (002-AST and 003-AST).

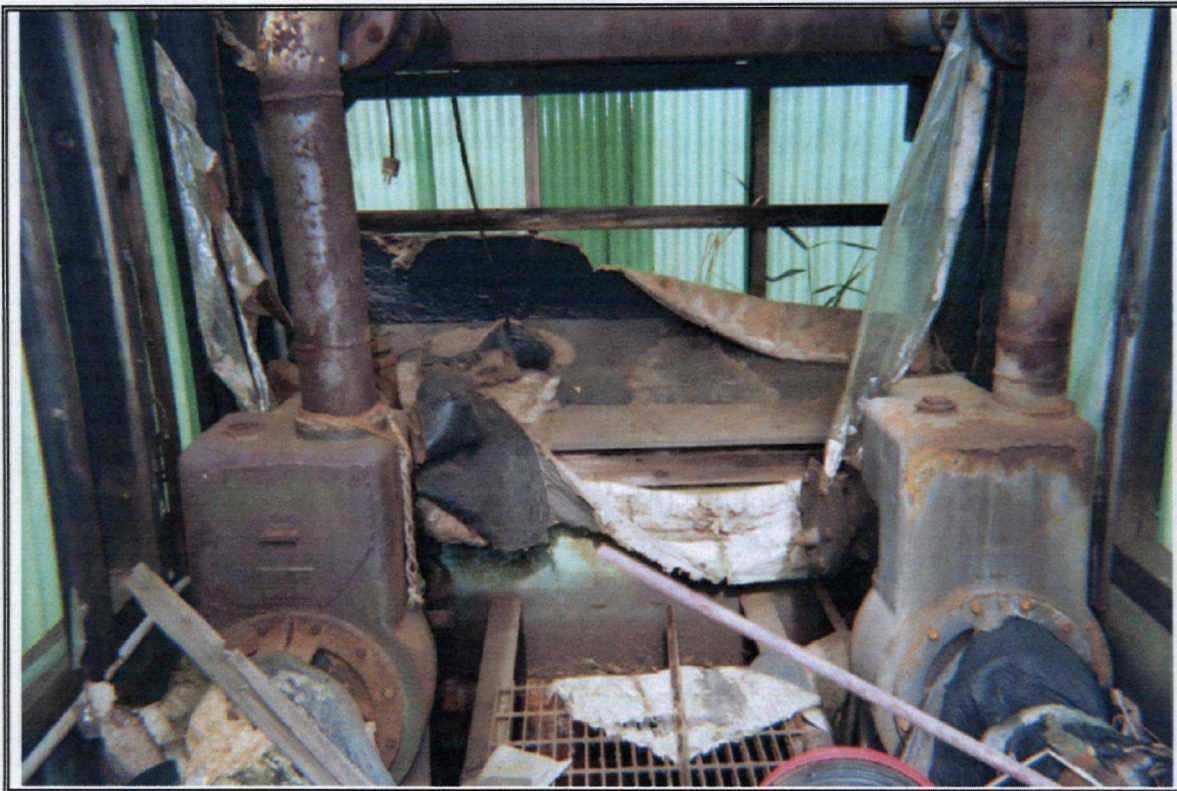
Photo No. 3

One sample (004-Little Bldg) was collected and analyzed from the wall insulation of the little pump house building. The results indicated no detectable asbestos.

Little Pump House Building (sample #004-Little Bldg).

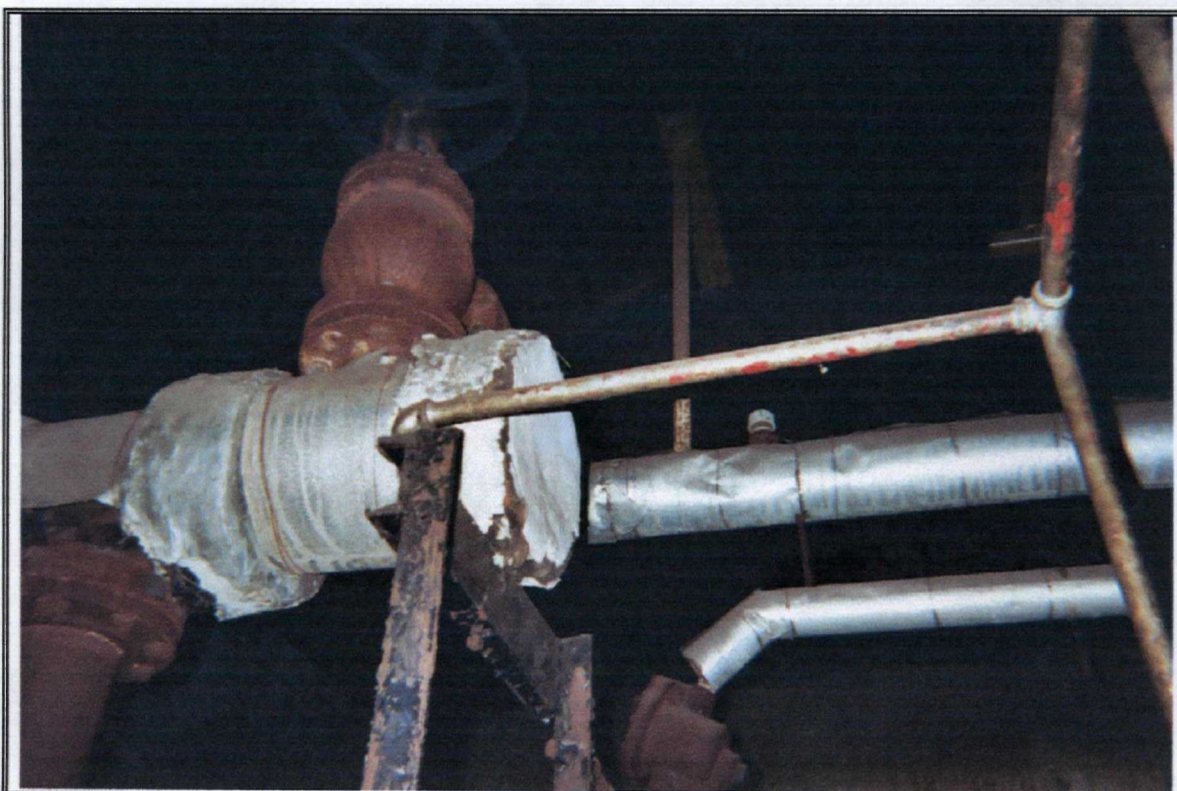
Photo No. 4

Sample 007-Bldg8 was collected and analyzed from the boiler pipe insulation. The sample results exhibited the presence of chrysotile asbestos at 35%.

Sample 008-Bldg8 was collected and analyzed from pipe insulation in Building 8. The sample results did not indicate any detectable asbestos.

Boiler pipe insulation and pipe run insulation (sample #s 007-Bldg8 and 008-Bldg8) in Building 8.

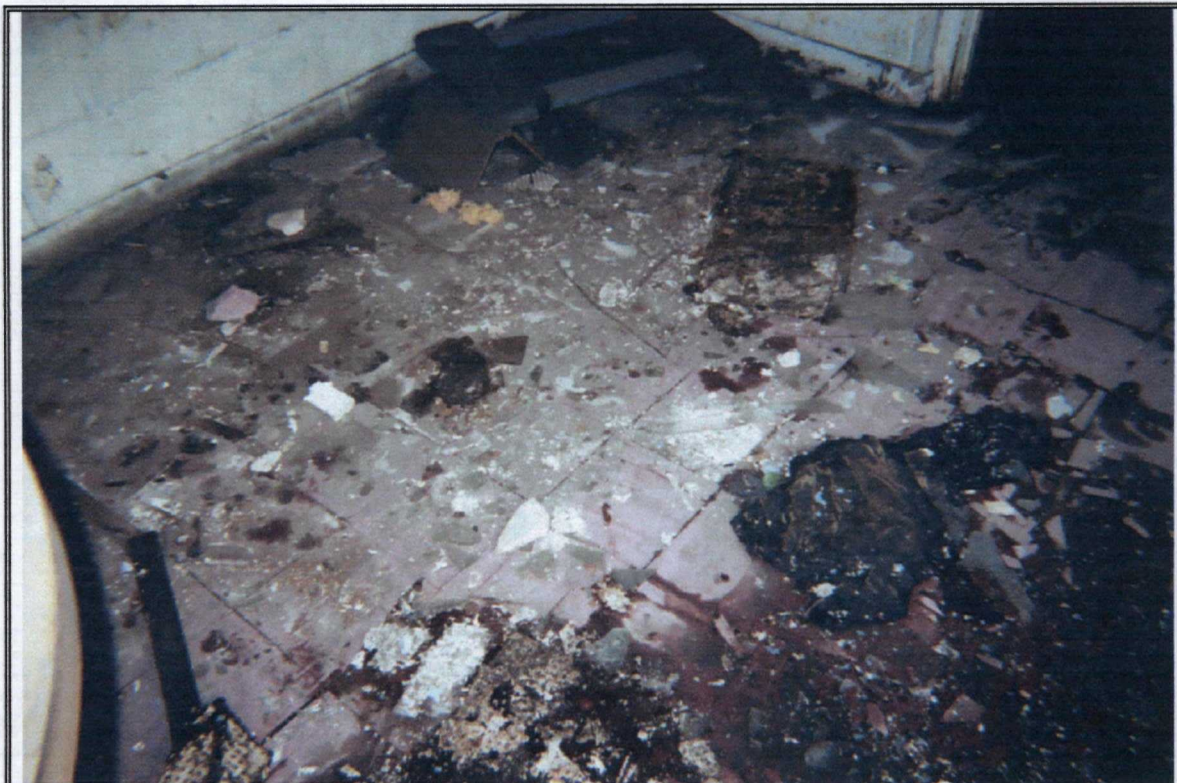
Photo No. 5

Building 9 (Room 1) 9" X 9" floor tile and mastic (sample #009-Bldg9). Also vinyl border molding, (sample # 010-Bldg9).

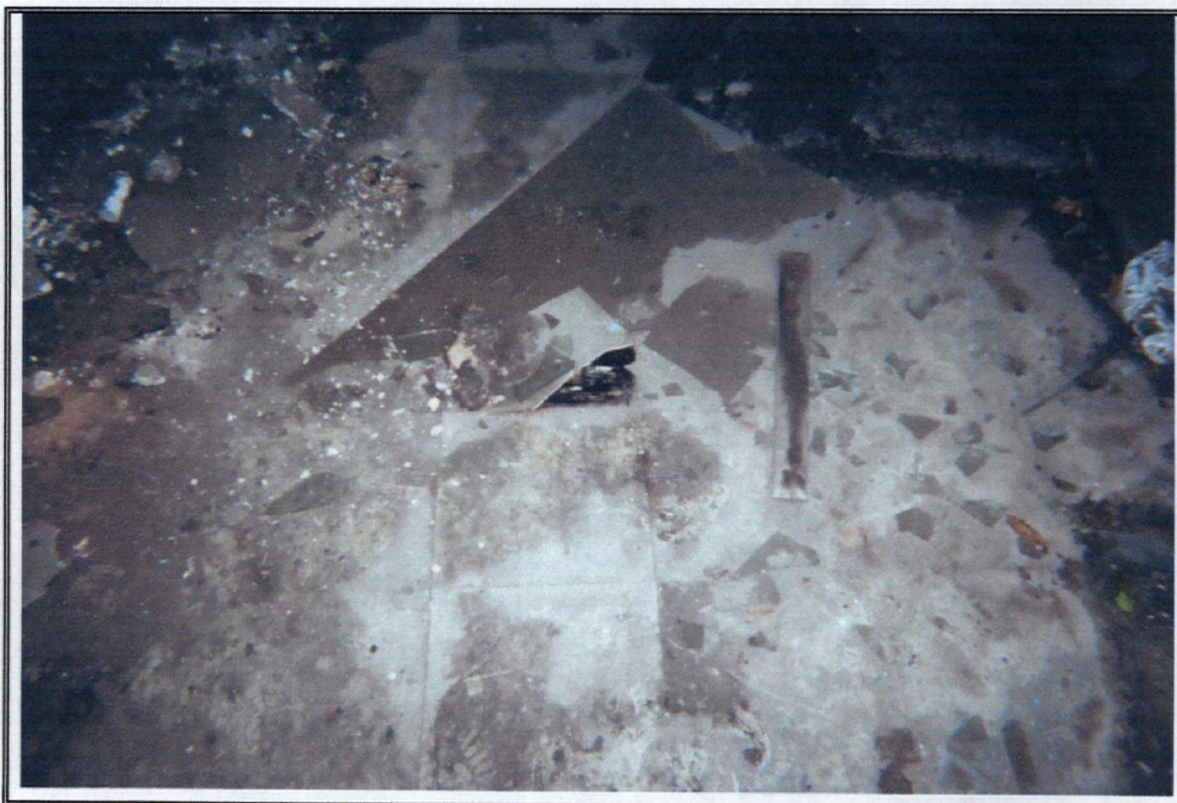
Photo No. 6

Building 9 (Room 3) 12"x 12" floor tile and mastic (sample # 011-Bldg9).

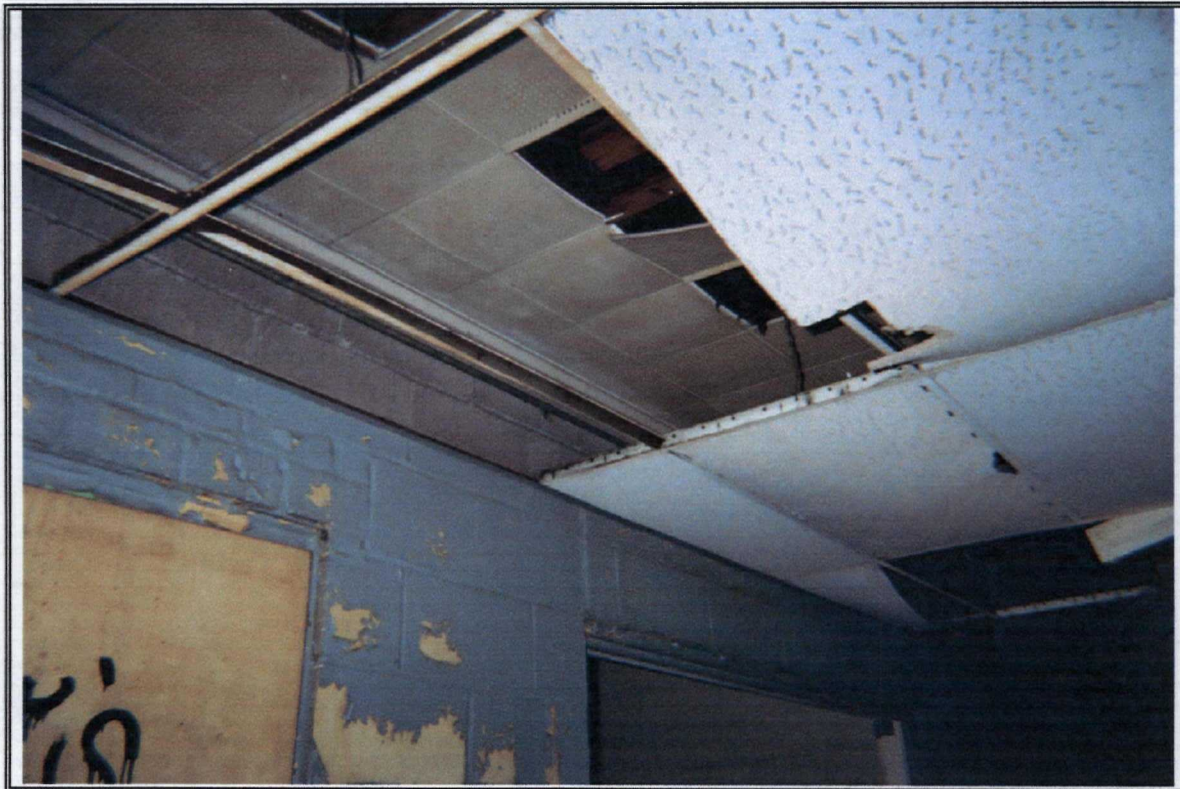
Photo No. 7

Building 9 (Room 2) 12" x 12" upper ceiling tile (sample # 012-Bldg9) and lower ceiling tile (sample # 015-Bldg9).

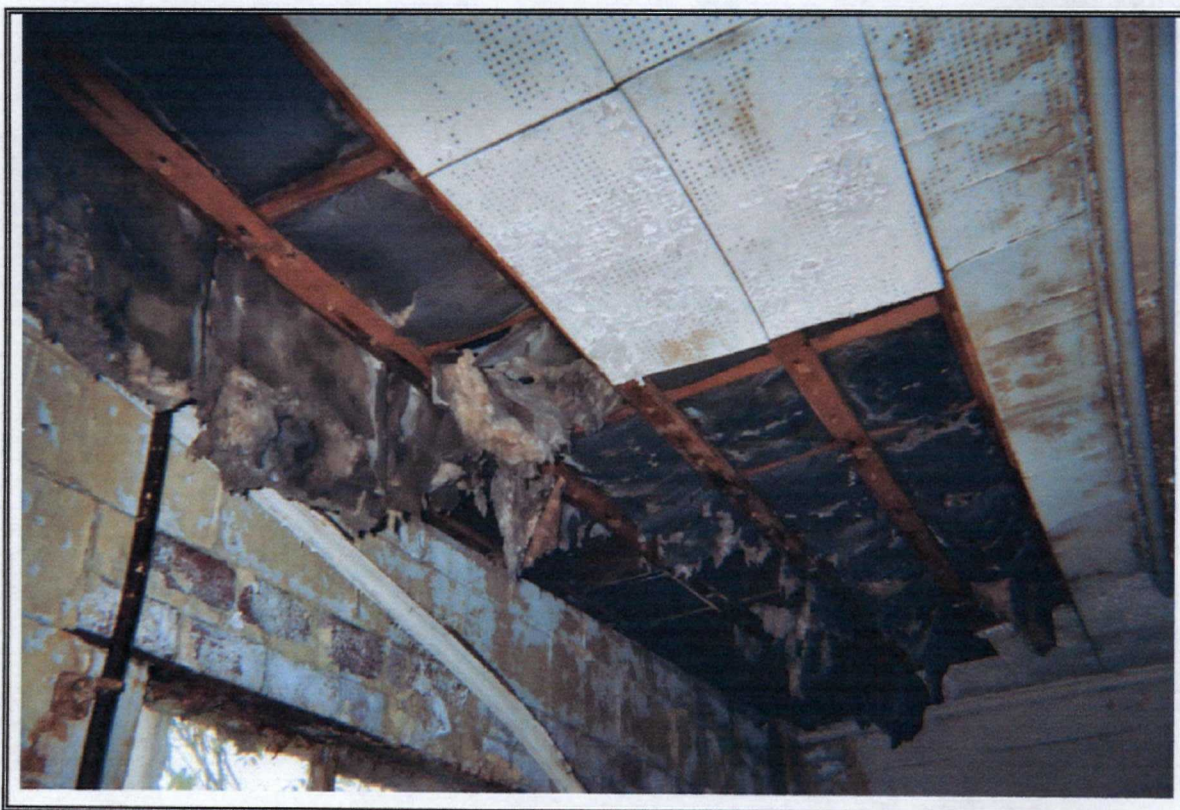
Photo No. 8

Building 9 (Room 1) ceiling insulation (sample # 016-Bldg9).

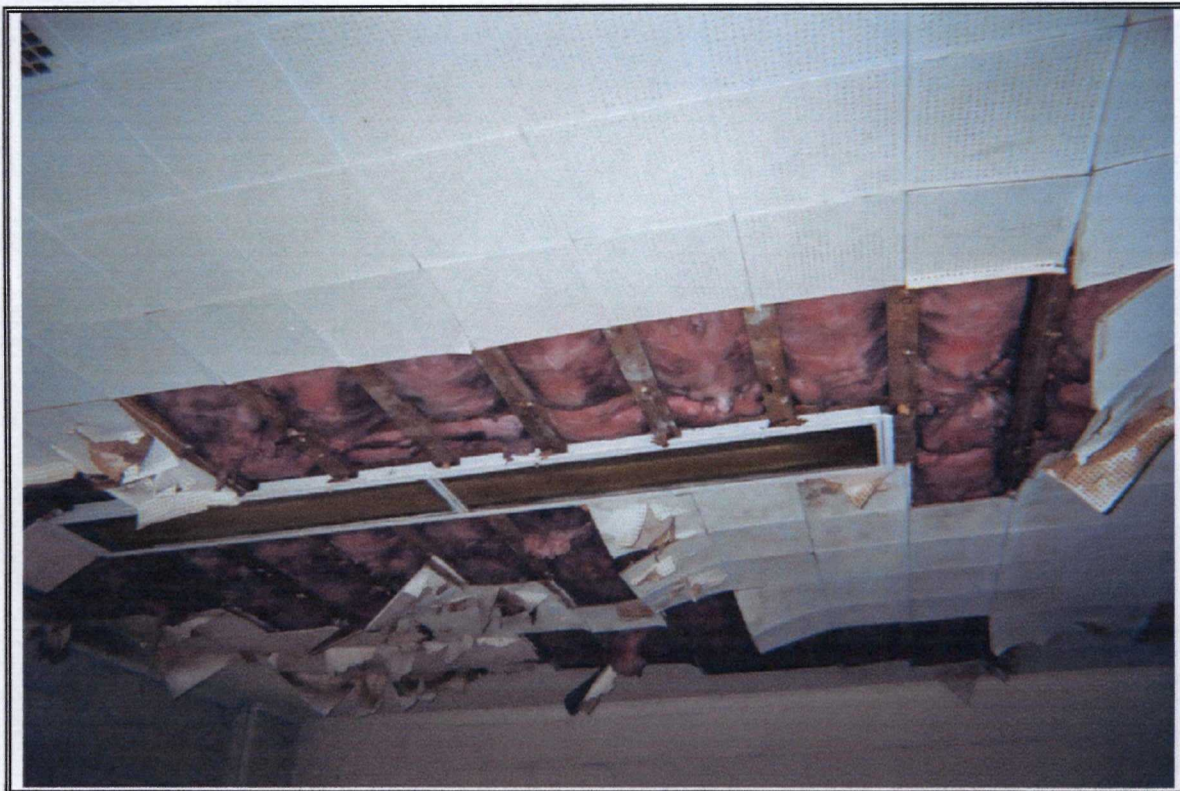
Photo No. 9

Building 9 (Room 6) ceiling insulation (sample # 017-Bldg9).

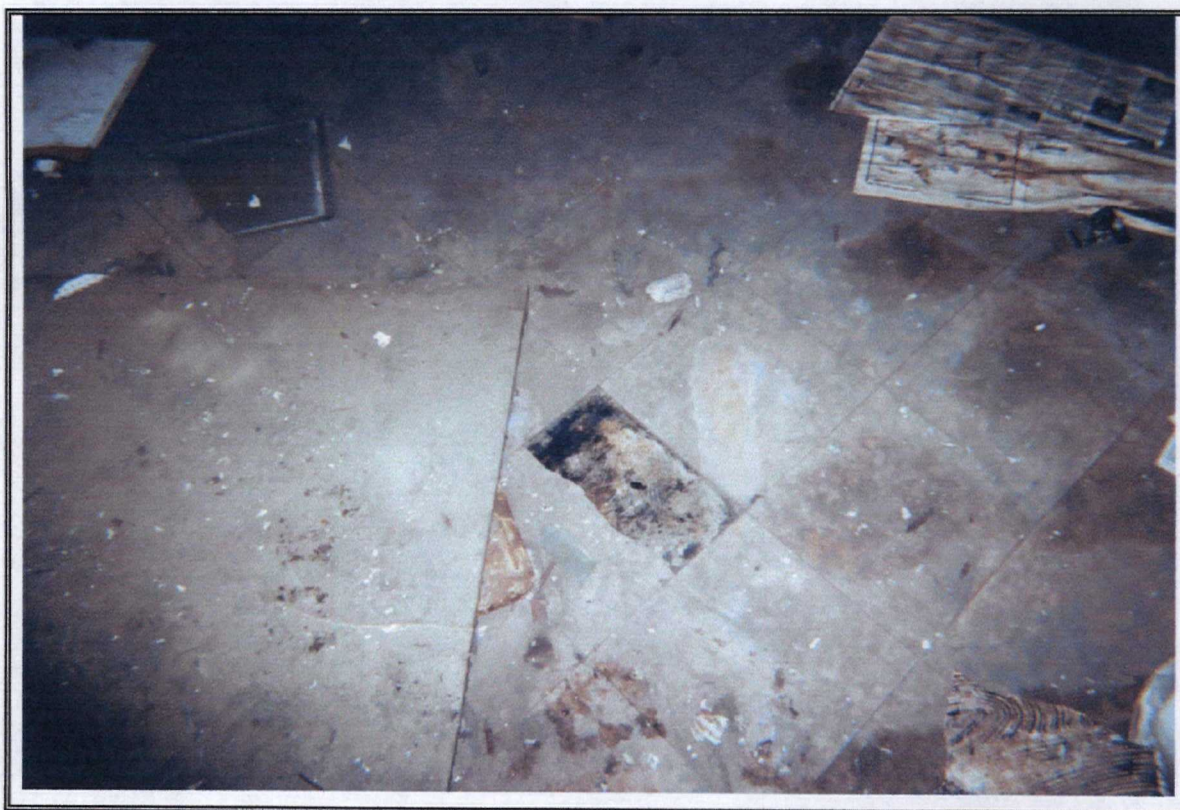
Photo No. 10

Building 9 (Room 4) 12" x 12" floor tile and mastic (sample # 018-Bldg9).

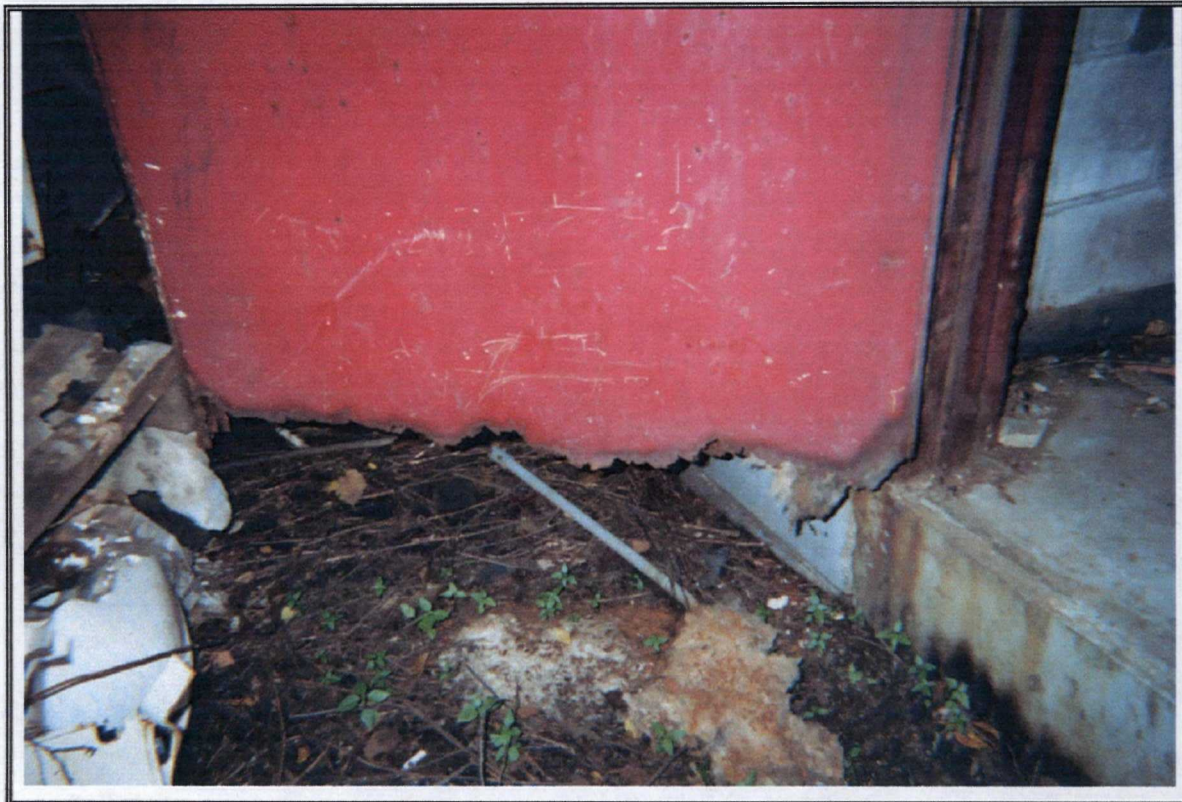
Photo No. 11

Sample 019-Bldg8 was collected and analyzed from insulation inside a steel fire door. The sample results did not indicate any detectable asbestos.

Building 8 fire door insulation (sample # 019-Bldg8).

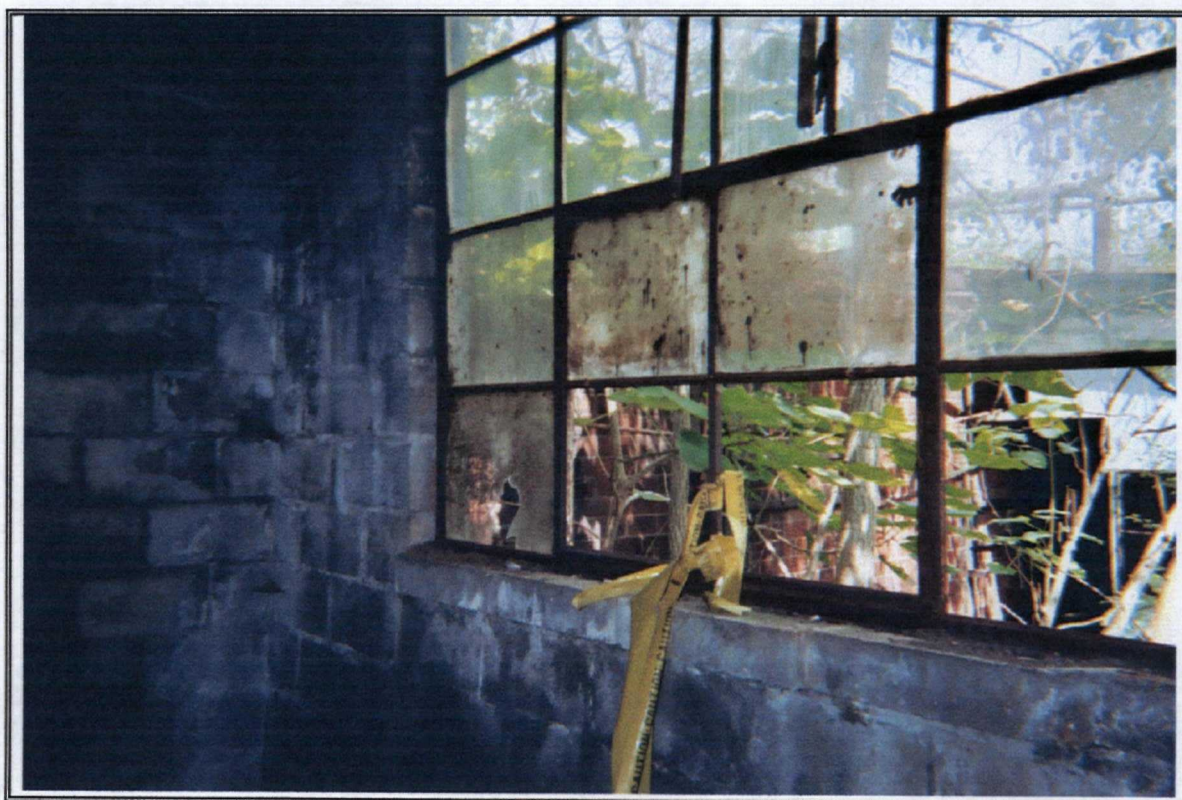
Photo No. 12

Sample 023-Bldg2 (Photo 12) was window caulking material collected from around one window pane. The results of this sample are considered to be representative of all window caulking in all buildings.

Building 2 window caulking (sample # 023-Bldg2).

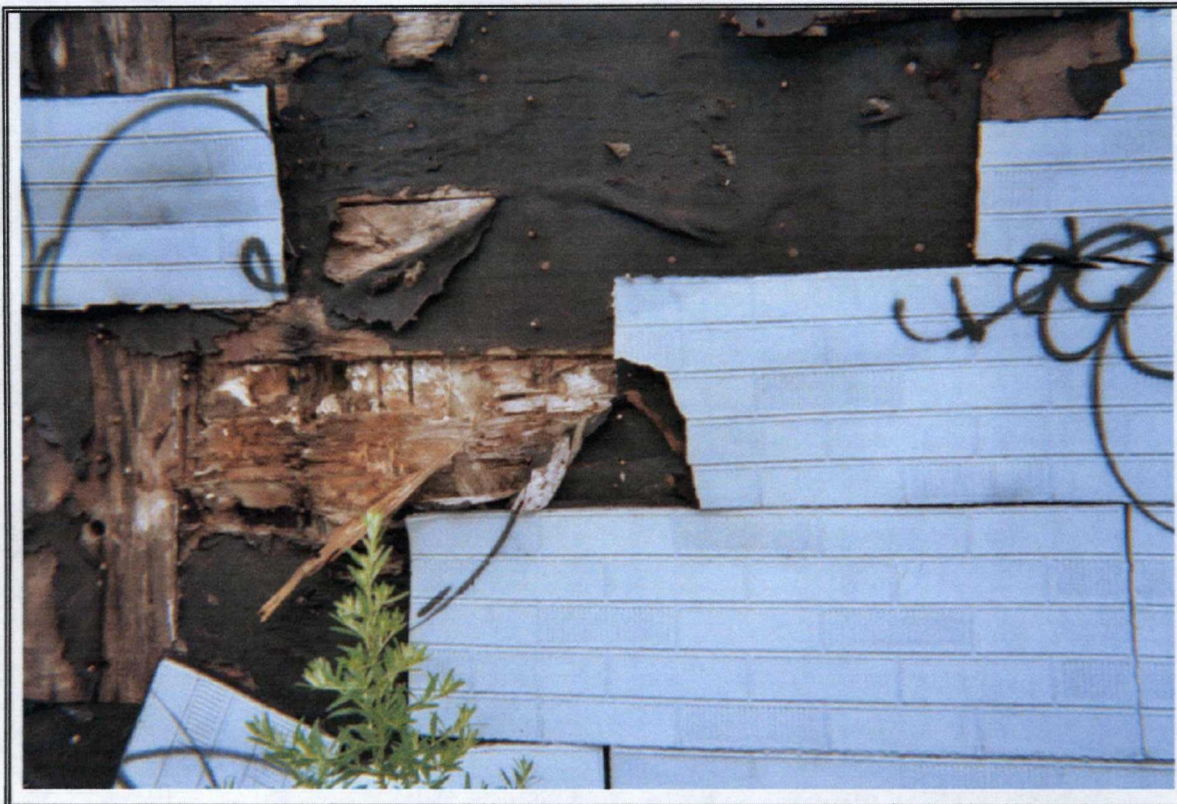
Photo No. 13

Only sample 028-Bldg6 (multi-layered outer wall)) was collected and analyzed from Building 7. The results did not indicate any detectable asbestos.

Building 7 exterior wall (sample # 028-Bldg7).

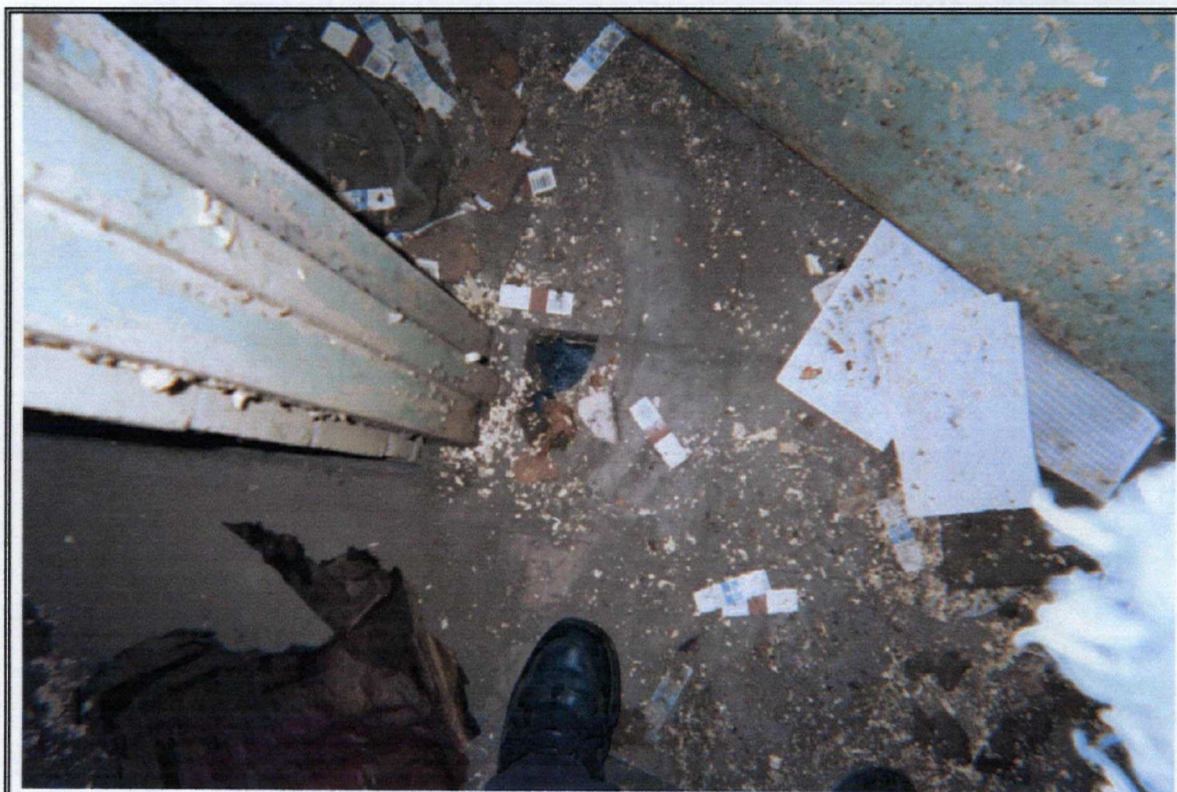
Photo No. 14

Building 4 Gate House 9" x 9" floor tile and mastic (sample # 024-Bldg4).

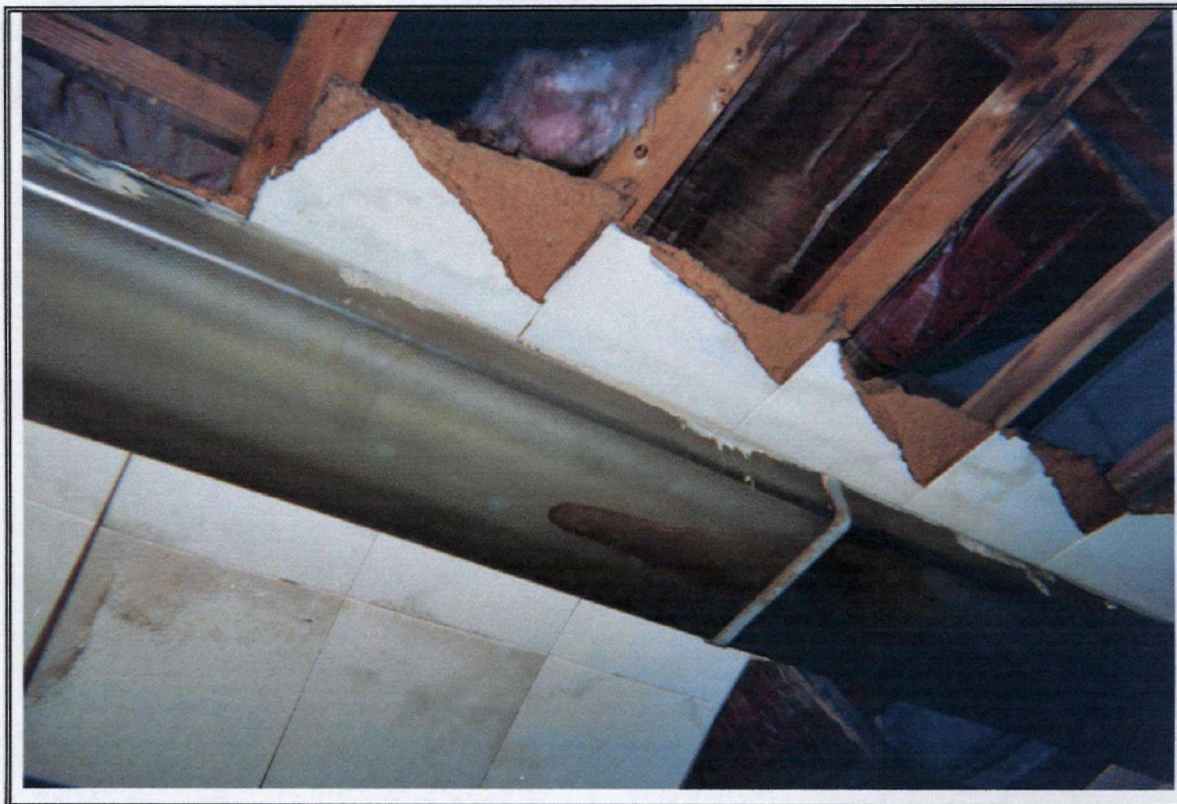
Photo No. 15

Building 4 Gate House 12" x 12" ceiling tile (025-Bldg4) and ceiling insulation (026-Bldg4).

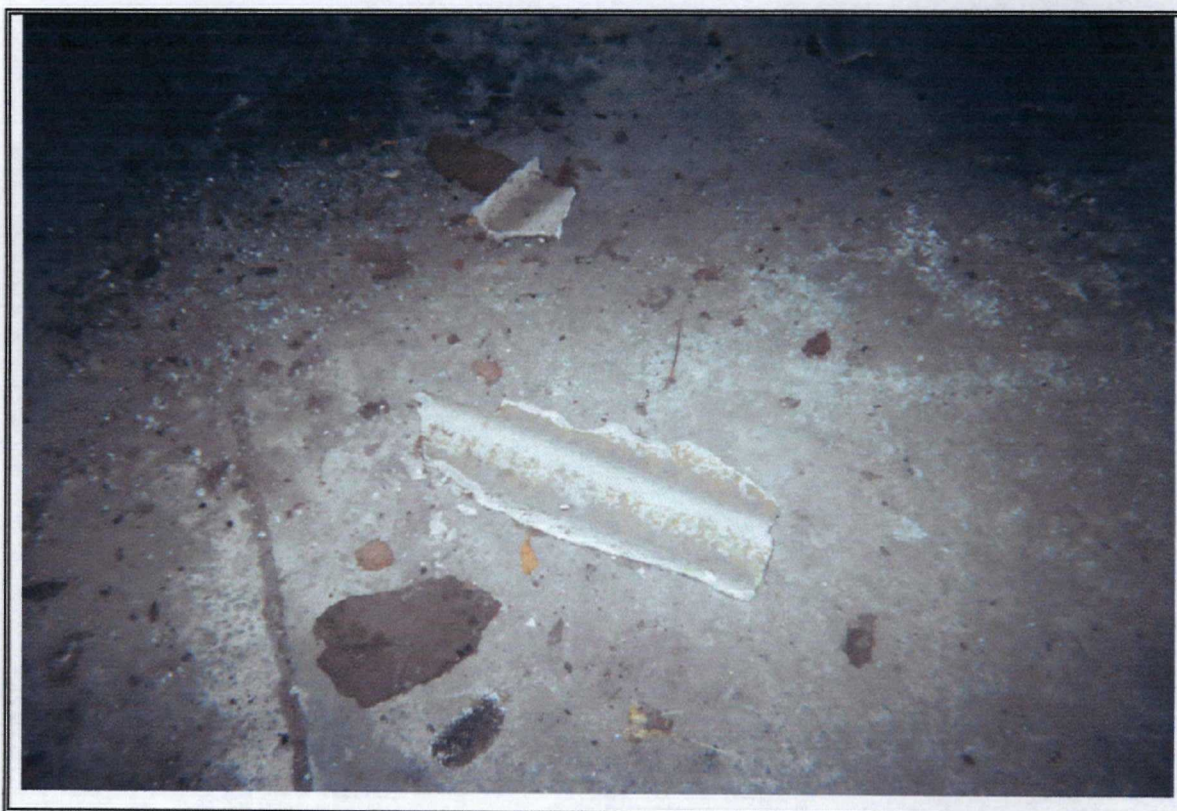
Photo No. 16

Sample 027-Bldg4 (transite piece on the floor) exhibited the presence of chrysotile asbestos at 18%.

Building 4 Transite roof inside building (sample # 027-Bldg4).

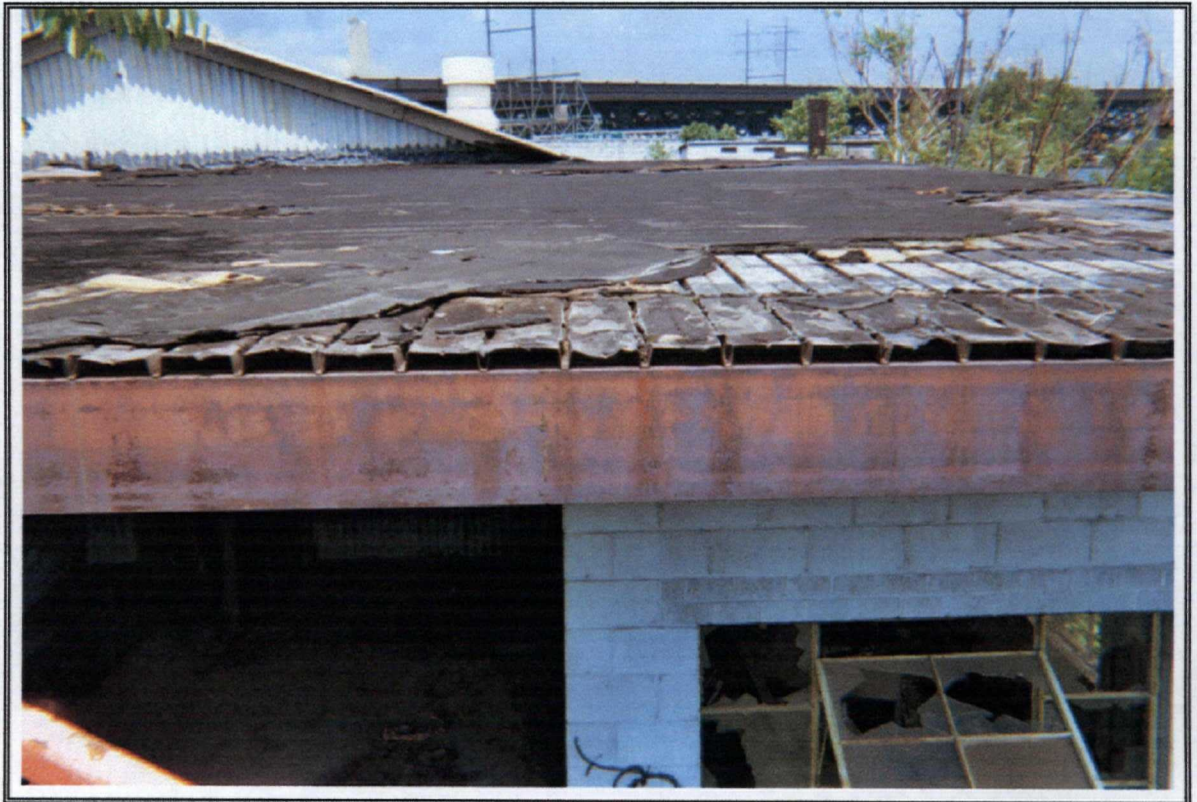
Photo No. 18

Samples 038-Bldg4 (roofing materials), 052-Bldg4 (pipe insulation) and 053-Bldg4 (pipe wrap) were collected and analyzed from the rear building. The result of sample 038-Bldg4 exhibited the presence of chrysotile asbestos at 20%. Samples 052-Bldg4 and 053-Bldg4 results did not indicate any detectable asbestos.

Building 4 rear roofing materials (sample # 038-Bldg4).

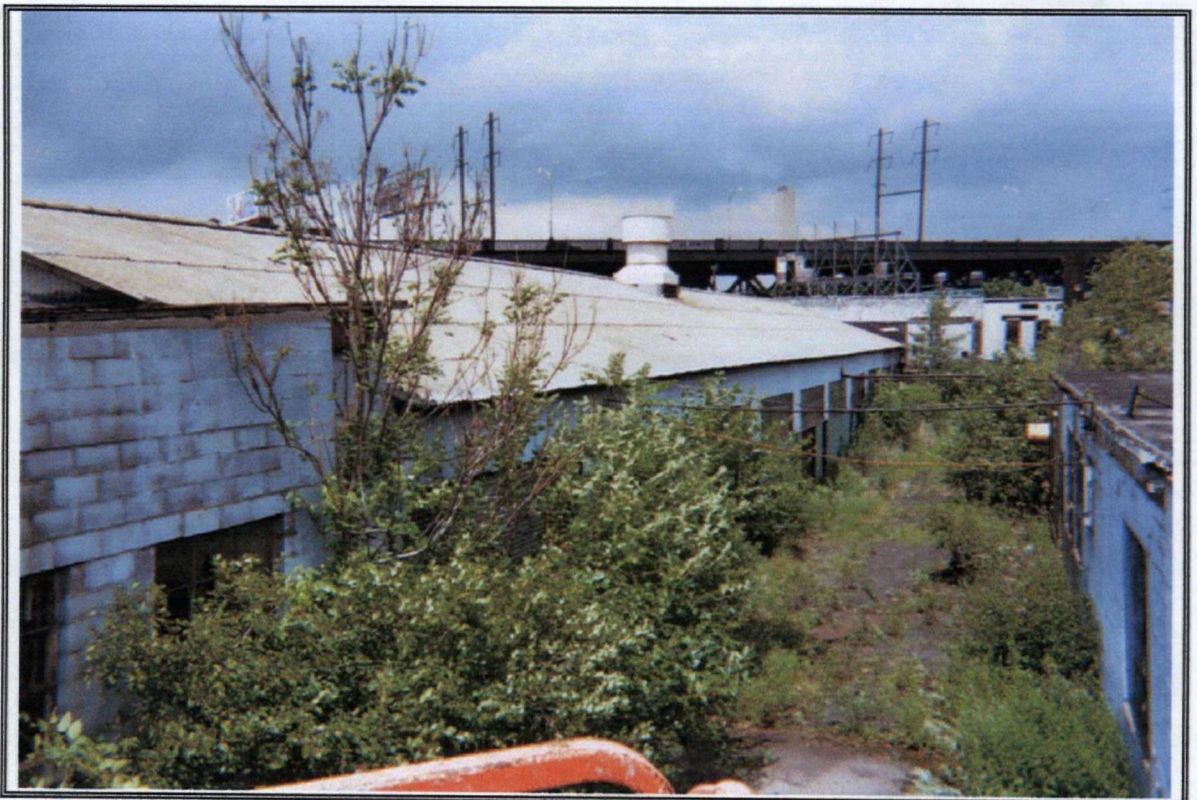
Photo No. 19

Sample 033-Bldg4 (Main Roof transite) and sample 34-Bldg4 (siding-top half transite) both exhibited the presence of chrysotile asbestos at 20% and 18%, respectively.

Building 4 main roof-transite (sample # 033-Bldg4) and sample (034-Bldg4) transite siding.

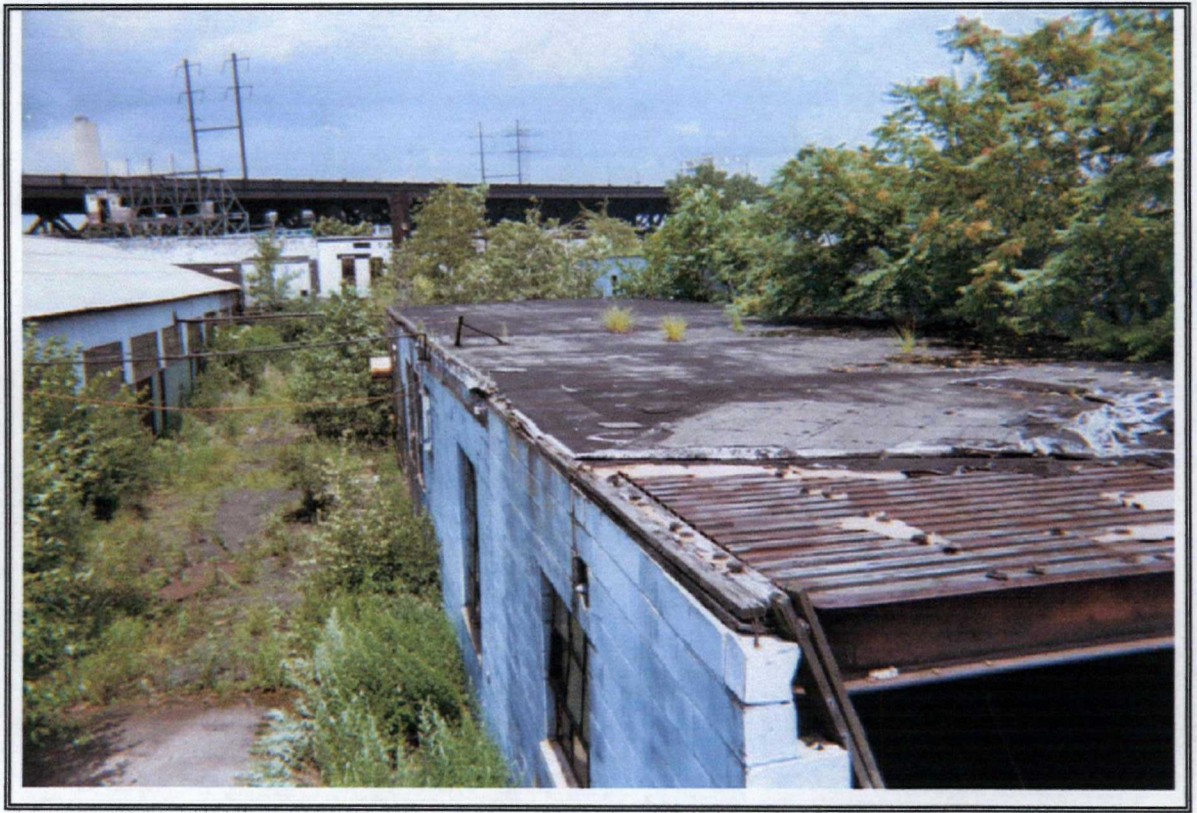
Photo No. 20

Building 2 roofing materials (sample # 035-Bldg2 and 036-Bldg2).

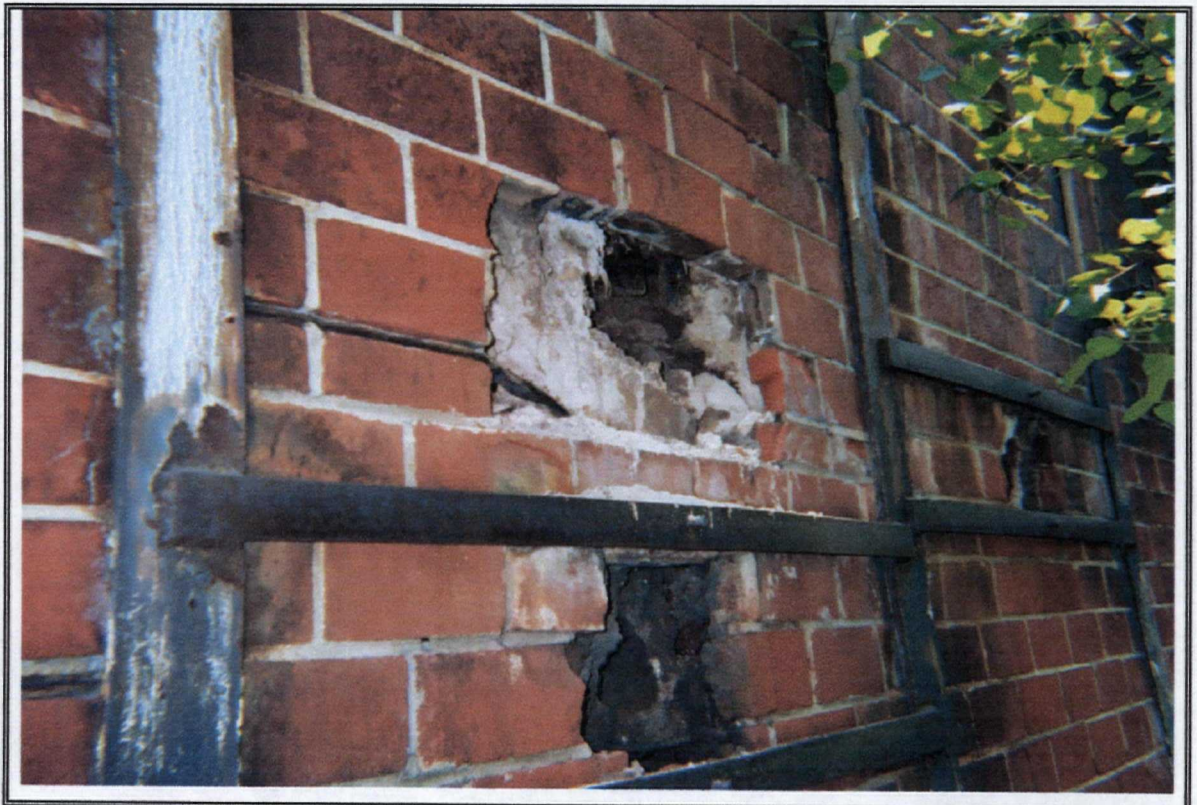
Photo No. 21

Sample 037-Bldg2 (furnace insulation) results did not indicate any detectable asbestos.

Building 2 furnace (incinerator) insulation (sample # 037-Bldg2).

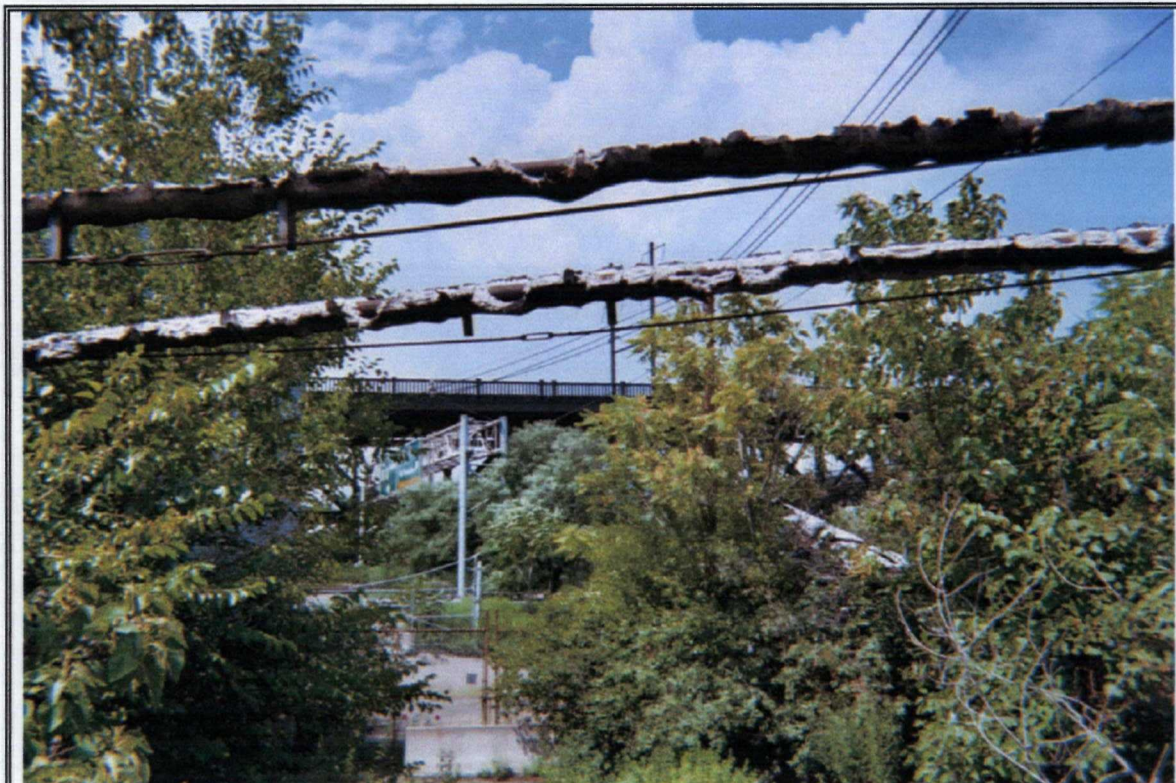
Photo No. 22

Two samples, 040-Bldg9 and 041-Bldg9 were collected and analyzed from the outer and inner piping wrap. These sample results did not indicate any detectable asbestos.

Piping between the corner of Building 7 and the corner of Building 3 (sample #s 039-Bldg3&7 and 040-Bldg3&7).

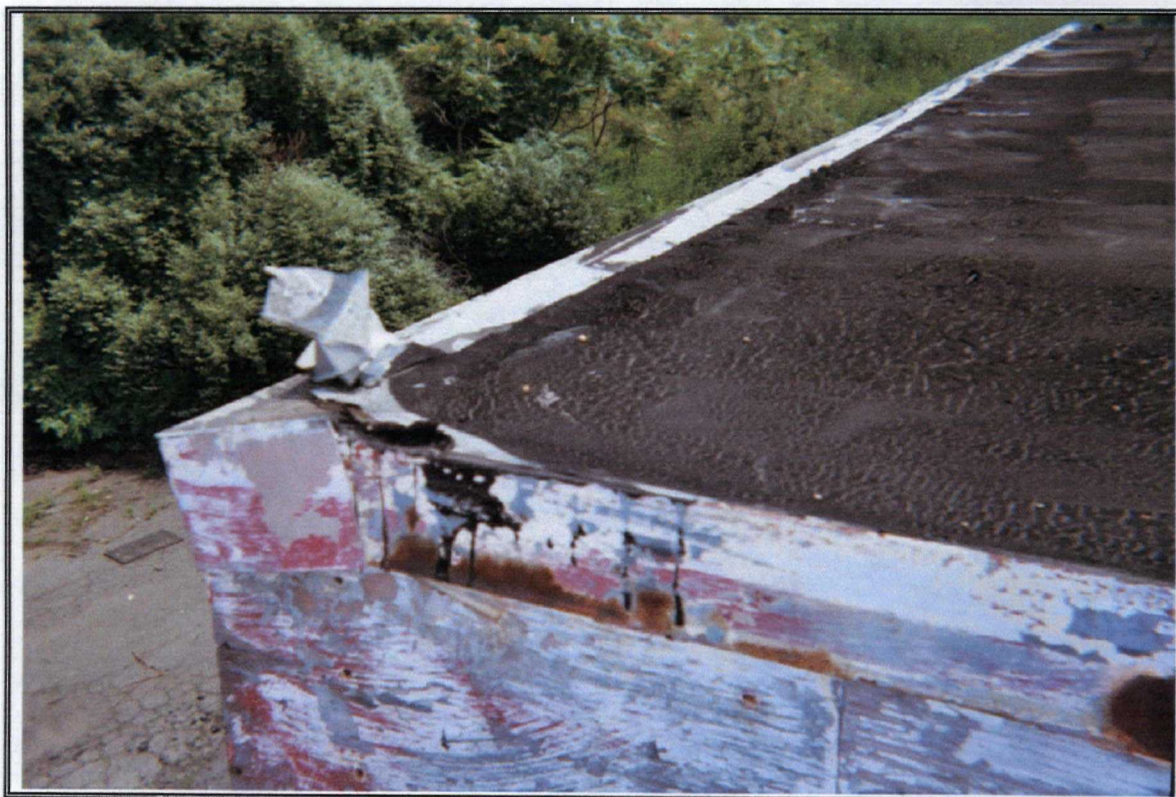
Photo No. 23

Building 9 roofing materials (sample #s 041-Bldg9 and 042-Bldg9).

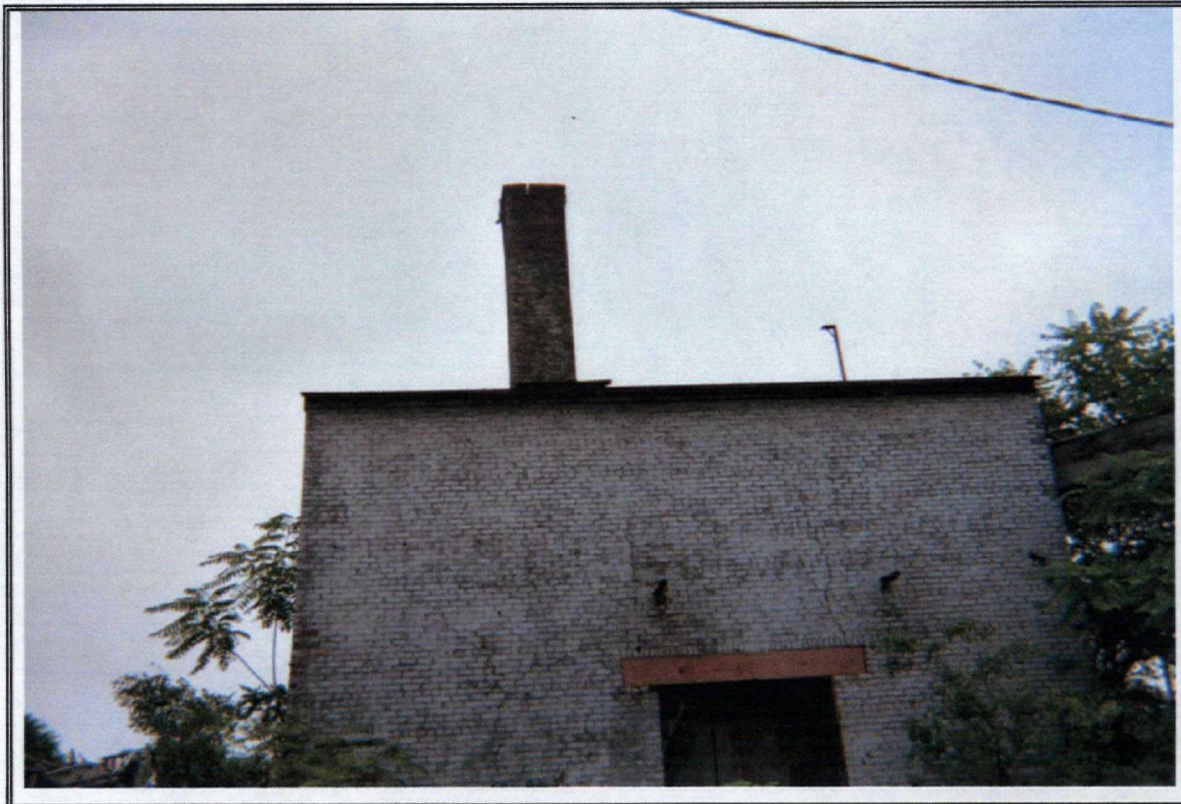
Photo No. 24

Building 8 roof materials (samples #s 043-Bldg8, 044-Bldg8 and 045-Bldg8).
